SMOKE TESTING OBSERVATION SUMMARY

Western Run Pilot Project - Baltimore Maryland

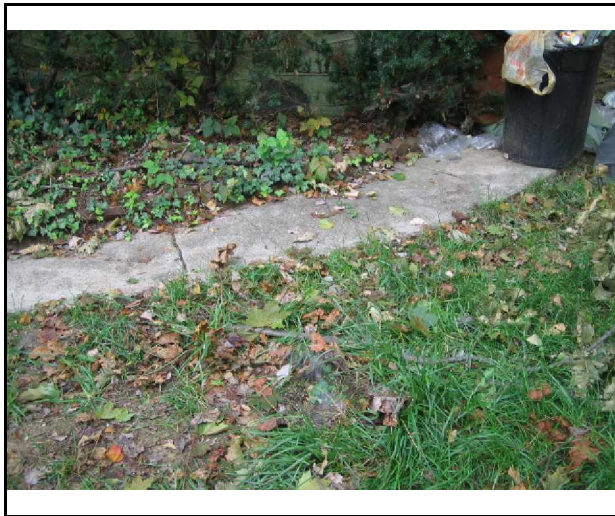
Photo No: 539

Unique Test ID	280	Date:	10/13/2004	MeterBasin:	01_WR29
Observer ID:	B	Crew:	T-2	Dye Test Recommended:	N
Defect No:	14	Setup No:	3	Priority CCTV:

House Number	7118	Street Prefix:		Street Name:	Park Heights	Street Type:	AVE
Source Type:	04= Cleanout	Location:	7=Yard-Front	Severity:	2=Trace		
Sector:	2=Private	Drainage Area:	4				
Comments:

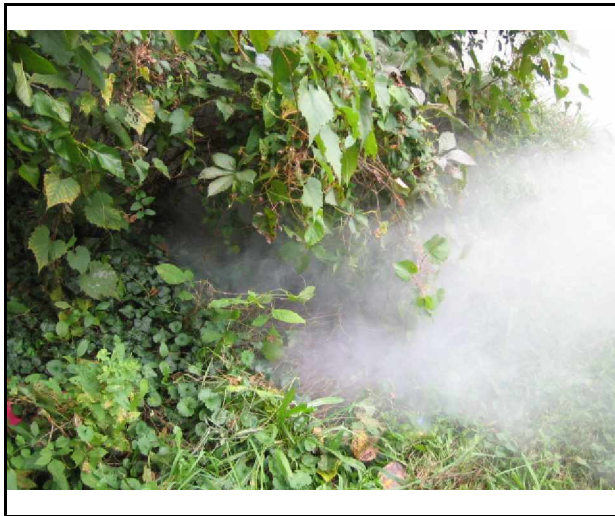
Photo No: 540

Unique Test ID	280	Date:	10/13/2004	MeterBasin:	01_WR29
Observer ID:	B	Crew:	T-2	Dye Test Recommended:	Y
Defect No:	15	Setup No:	3	Priority CCTV:

House Number	Street Prefix:	Street Name:	Street Type:		
7120		Park Heights	AVE		
Source Type:	14= Catch Basin	Location:	7=Yard-Front	Severity:	4=Major
Sector:	1=Public	Drainage Area:	40000		
Comments:	south curb

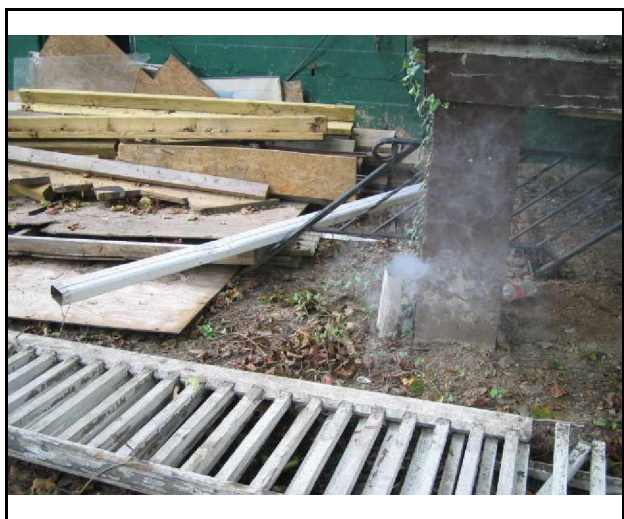
Photo No: 541

Unique Test ID	280	Date:	10/13/2004	MeterBasin:	01_WR29
Observer ID:	B	Crew:	T-2	Dye Test Recommended:	N
Defect No:	16	Setup No:	3	Priority CCTV:

House Number	7126	Street Prefix:		Street Name:	Park Heights	Street Type:	AVE
Source Type:	06= Dwnspt Connect	Location:	9=Yard-Side	Severity:	4=Major		
Sector:	2=Private	Drainage Area:	1000				
Comments:

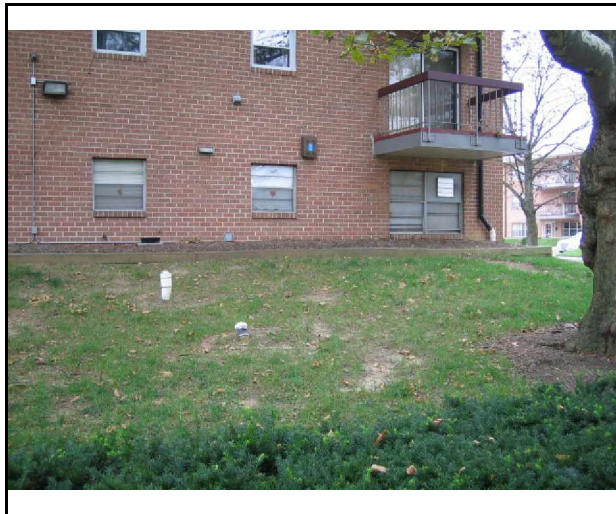
Photo No: 542

Unique Test ID	280	Date:	10/13/2004	MeterBasin:	
Observer ID:	B	Crew:	T-2	Dye Test Recommended:	N
Defect No:	2	Setup No:	3	Priority CCTV:

House Number	Street Prefix:	Street Name:	Street Type:
3617		Glengyle	AVE

Source Type:	04= Cleanout	Location:	7=Yard-Front	Severity:	4=Major
Sector:	2=Private	Drainage Area:	0		
Comments:	8-a

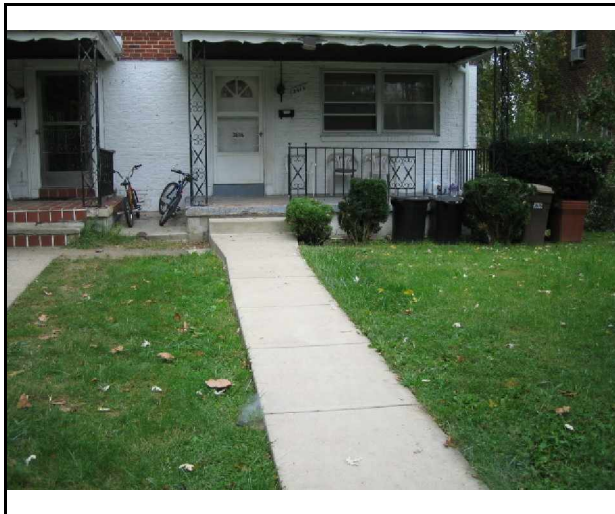
Photo No: 528

Unique Test ID	280	Date:	10/13/2004	MeterBasin:	01_WR32
Observer ID:	B	Crew:	T-2	Dye Test Recommended:	N
Defect No:	3	Setup No:	3	Priority CCTV:

House Number	3616	Street Prefix:		Street Name:	Glengyle	Street Type:	AVE
Source Type:	04= Cleanout	Location:	7=Yard-Front	Severity:	4=Major		
Sector:	2=Private	Drainage Area:	0				
Comments:

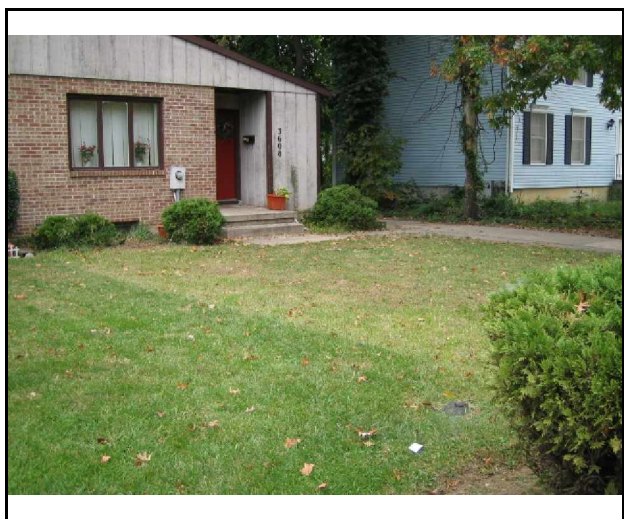
Photo No: 529

Unique Test ID	280	Date:	10/13/2004	MeterBasin:	01_WR29
Observer ID:	B	Crew:	T-2	Dye Test Recommended:	N
Defect No:	4	Setup No:	3	Priority CCTV:

House Number	3608	Street Prefix:		Street Name:	Glengyle	Street Type:	AVE
Source Type:	04= Cleanout	Location:	7=Yard-Front	Severity:	3=Moderate		
Sector:	2=Private	Drainage Area:	0				
Comments:

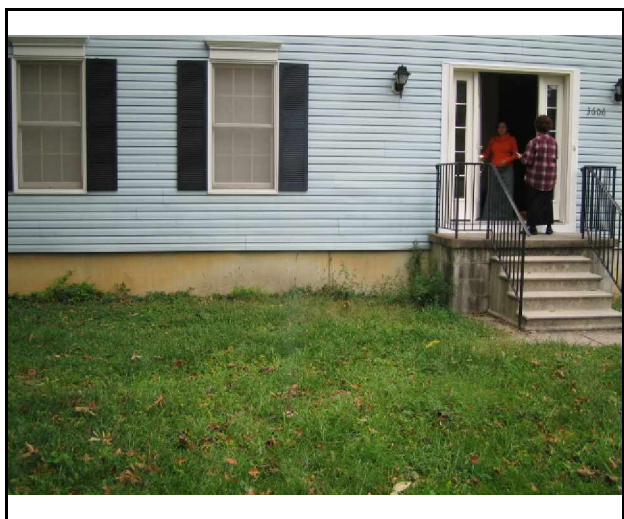
Photo No: 530

Unique Test ID	280	Date:	10/13/2004	MeterBasin:	01_WR29
Observer ID:	B	Crew:	T-2	Dye Test Recommended:	N
Defect No:	5	Setup No:	3	Priority CCTV:

House Number	3606	Street Prefix:		Street Name:	Glengyle	Street Type:	AVE
Source Type:	04= Cleanout	Location:	7=Yard-Front	Severity:	4=Major		
Sector:	2=Private	Drainage Area:	0				
Comments:

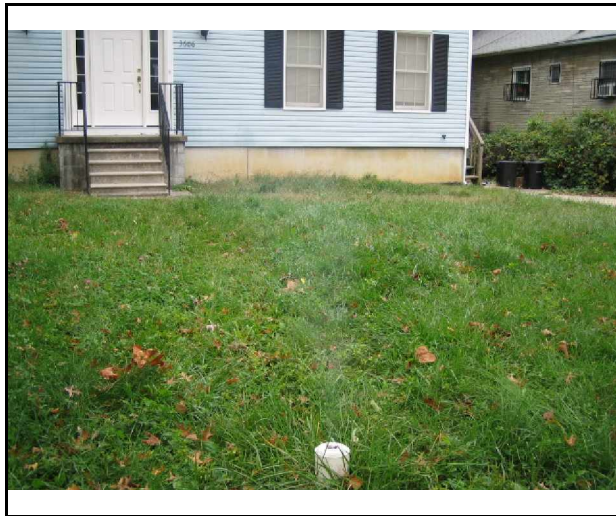
Photo No: 531

Unique Test ID	280	Date:	10/13/2004	MeterBasin:	01_WR29
Observer ID:	B	Crew:	T-2	Dye Test Recommended:	N
Defect No:	6	Setup No:	3	Priority CCTV:

House Number	3606	Street Prefix:		Street Name:	Glengyle	Street Type:	AVE
Source Type:	04= Cleanout	Location:	7=Yard-Front	Severity:	4=Major		
Sector:	2=Private	Drainage Area:	0				
Comments:

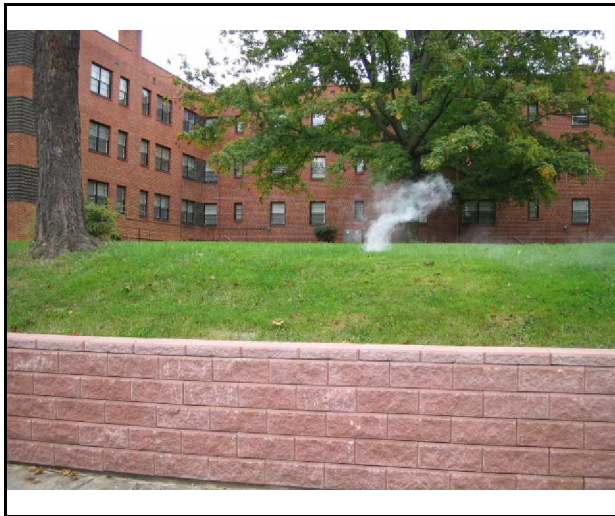
Unique Test ID	280	Date:	10/13/2004	MeterBasin:	
Observer ID:	B	Crew:	T-2	Dye Test Recommended:	N
Defect No:	7	Setup No:	3	Priority CCTV:

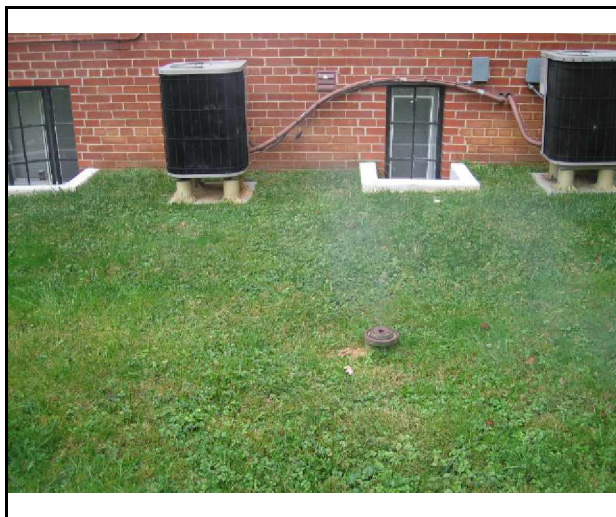
Unique Test ID	280	Date:	10/13/2004	MeterBasin:	
Observer ID:	B	Crew:	T-2	Dye Test Recommended:	N
Defect No:	8	Setup No:	3	Priority CCTV:

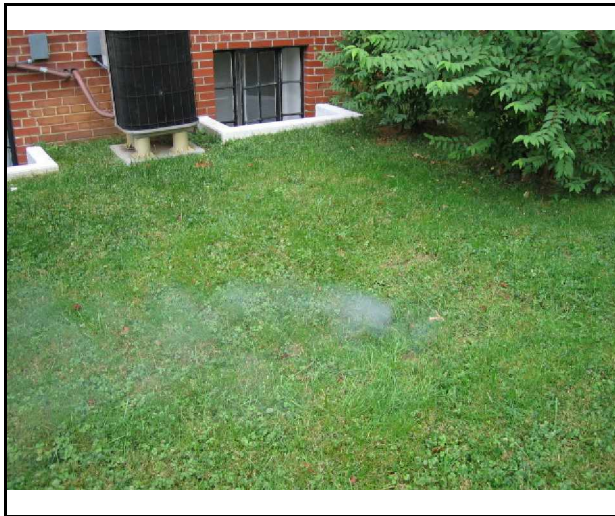
Unique Test ID	280	Date:	10/13/2004	MeterBasin:	
Observer ID:	B	Crew:	T-2	Dye Test Recommended:	N
Defect No:	9	Setup No:	3	Priority CCTV:

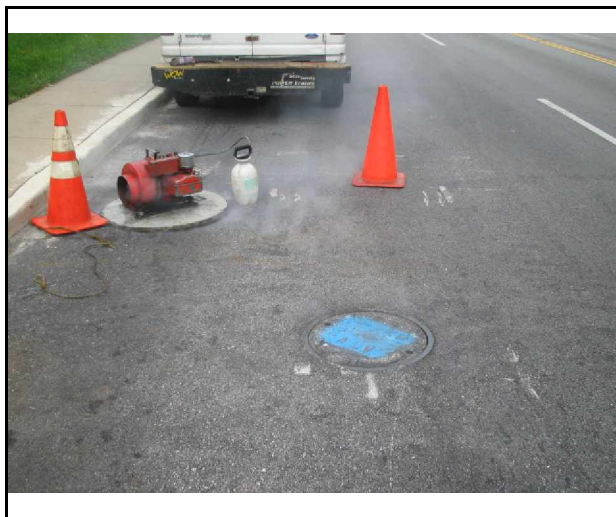
Unique Test ID	281	Date:	10/13/2004	MeterBasin:	01_WR29
Observer ID:	B	Crew:	T-2	Dye Test Recommended:	N
Defect No:	1	Setup No:	4	Priority CCTV:

House Number	Street Prefix:	Street Name:	Street Type:		
7000		Park Heights	AVE		
Source Type:	18= Other	Location:	2=Paved Asphalt	Severity:	4=Major
Sector:	1=Public	Drainage Area:	4		
Comments:

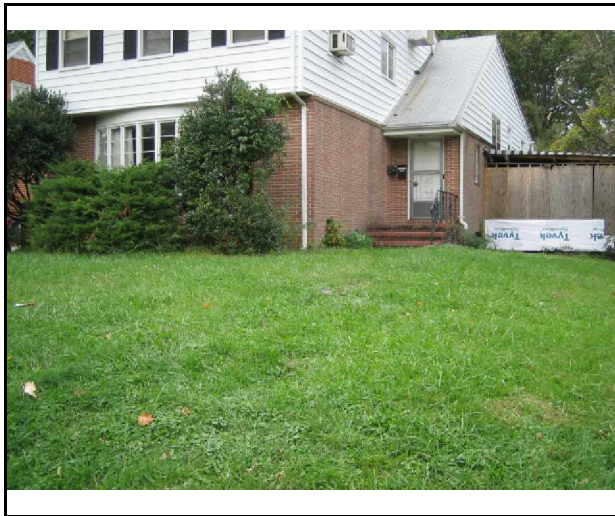
Unique Test ID	281	Date:	10/13/2004	MeterBasin:	01_WR29
Observer ID:	B	Crew:	T-2	Dye Test Recommended:	N
Defect No:	10	Setup No:	4	Priority CCTV:

House Number	3502	Street Prefix:		Street Name:	Olympia	Street Type:	AVE
Source Type:	04= Cleanout	Location:	7=Yard-Front	Severity:	4=Major		
Sector:	2=Private	Drainage Area:	0				
Comments:

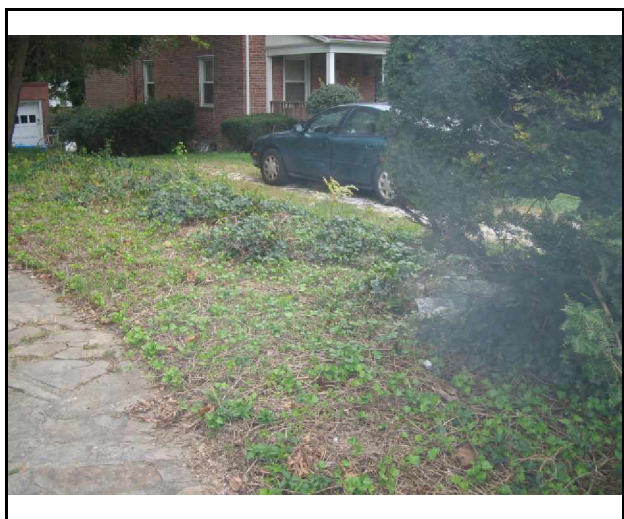
Unique Test ID	281	Date:	10/13/2004	MeterBasin:	01_WR29
Observer ID:	B	Crew:	T-2	Dye Test Recommended:	N
Defect No:	2	Setup No:	4	Priority CCTV:

House Number	Street Prefix:	Street Name:	Street Type:		
7007		Park Heights	AVE		
Source Type:	04= Cleanout	Location:	7=Yard-Front	Severity:	4=Major
Sector:	2=Private	Drainage Area:	0		
Comments:

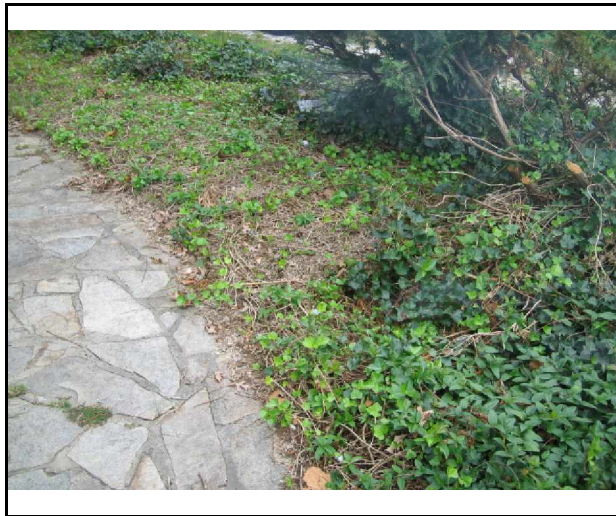
Unique Test ID	281	Date:	10/13/2004	MeterBasin:	01_WR29
Observer ID:	B	Crew:	T-2	Dye Test Recommended:	N
Defect No:	3	Setup No:	4	Priority CCTV:

House Number	Street Prefix:	Street Name:	Street Type:		
7007		Park Heights	AVE		
Source Type:	02= Service Line	Location:	7=Yard-Front	Severity:	2=Trace
Sector:	2=Private	Drainage Area:	16		
Comments:

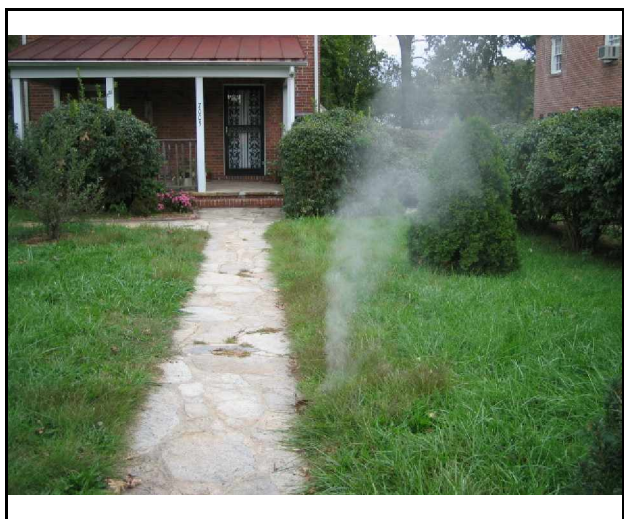
Unique Test ID	281	Date:	10/13/2004	MeterBasin:	01_WR29
Observer ID:	B	Crew:	T-2	Dye Test Recommended:	N
Defect No:	4	Setup No:	4	Priority CCTV:

House Number	Street Prefix:	Street Name:	Street Type:		
7005		Park Heights	AVE		
Source Type:	04= Cleanout	Location:	7=Yard-Front	Severity:	4=Major
Sector:	2=Private	Drainage Area:	0		
Comments:

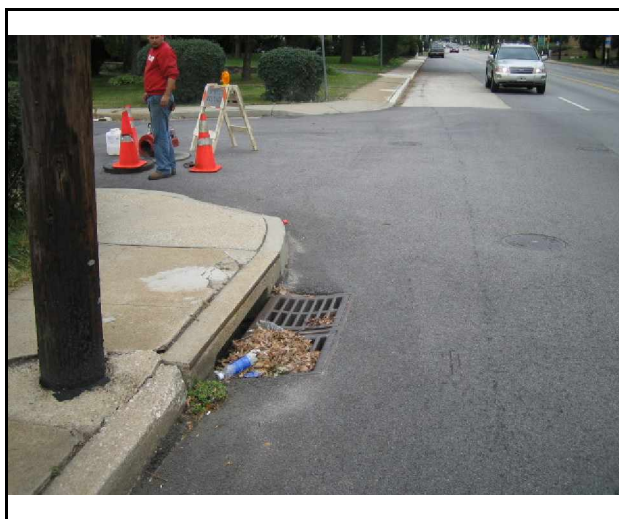
Unique Test ID	281	Date:	10/13/2004	MeterBasin:	01_WR29
Observer ID:	B	Crew:	T-2	Dye Test Recommended:	Y
Defect No:	5	Setup No:	4	Priority CCTV:

House Number	Street Prefix:	Street Name:	Street Type:		
7001		Park Heights	AVE		
Source Type:	14= Catch Basin	Location:	6=Curb	Severity:	3=Moderate
Sector:	1=Public	Drainage Area:	30000		
Comments:	north corner

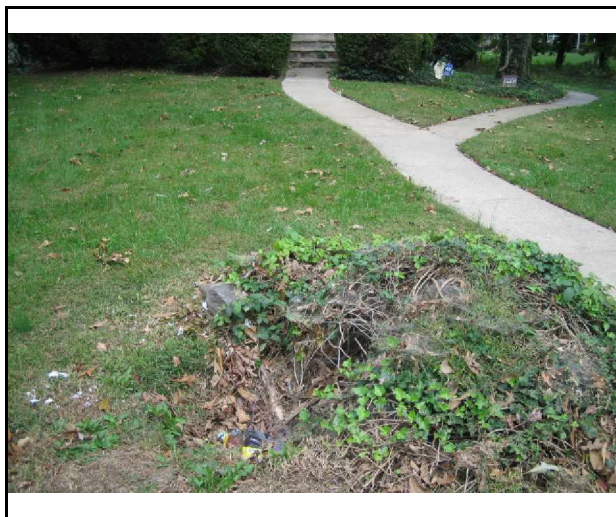
Unique Test ID	281	Date:	10/13/2004	MeterBasin:	01_WR29
Observer ID:	B	Crew:	T-2	Dye Test Recommended:	N
Defect No:	6	Setup No:	4	Priority CCTV:

House Number	6911	Street Prefix:		Street Name:	Park Heights	Street Type:	AVE
Source Type:	02= Service Line	Location:	7=Yard-Front	Severity:	2=Trace		
Sector:	2=Private	Drainage Area:	16				
Comments:

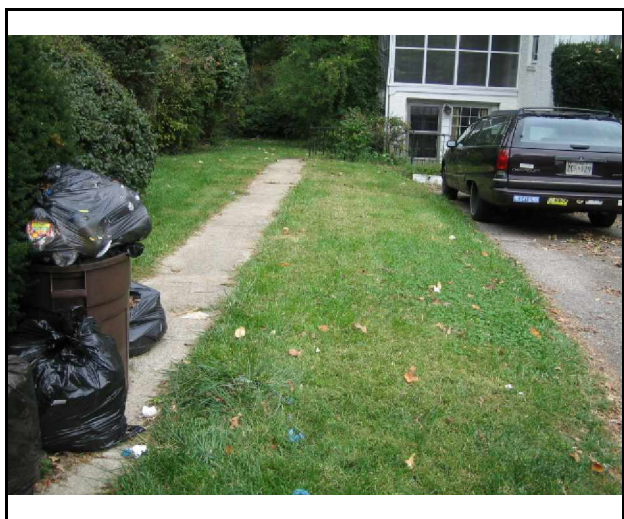
Unique Test ID	281	Date:	10/13/2004	MeterBasin:	01_WR29
Observer ID:	B	Crew:	T-2	Dye Test Recommended:	N
Defect No:	7	Setup No:	4	Priority CCTV:

House Number	6905	Street Prefix:		Street Name:	Park Heights	Street Type:	AVE
Source Type:	04= Cleanout	Location:	7=Yard-Front	Severity:	2=Trace		
Sector:	2=Private	Drainage Area:	0				
Comments:

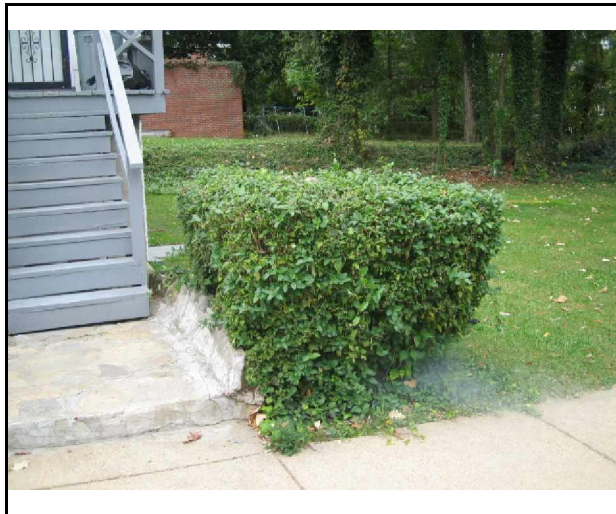
Unique Test ID	281	Date:	10/13/2004	MeterBasin:	01_WR29
Observer ID:	B	Crew:	T-2	Dye Test Recommended:	N
Defect No:	8	Setup No:	4	Priority CCTV:

House Number	Street Prefix:	Street Name:	Street Type:		
7001		Park Heights	AVE		
Source Type:	02= Service Line	Location:	9=Yard-Side	Severity:	3=Moderate
Sector:	2=Private	Drainage Area:	18		
Comments:
